NASA TN D-2884

## DEVELOPMENT OF A HEMISPHERICAL METAL DIAPHRAGM FOR SINGLE-CYCLE LIQUID-METAL POSITIVE EXPULSION SYSTEMS

*by Sol Gorland*

*Lewis Research Center  
Cleveland, Ohio*

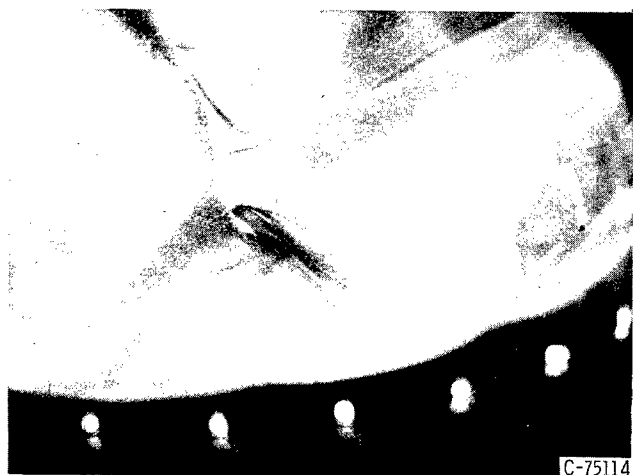
(a) Initial deformation showing asymmetry (2 percent expulsion).

(b) Sharp-edged cornering (5 percent expulsion).

(c) Pyramid-type deformation (15 percent expulsion).

(d) Pyramid-type deformation closeup (15 percent expulsion).

Figure 7. - Progressive deformation of diaphragm during expulsion cycle. Configuration A; test 1, 0.016-inch-thick diaphragm; flow rate, ~190 pounds per hour.

(e) Asymmetry of deformation (25 percent expulsion).

(f) Three corner fold as a result of torsional deformation (65 percent expulsion).

The first expulsion test was run as a shakedown for the experimental procedure and equipment. The flow rate as shown in table I was 190 pounds per hour. Deformation of the diaphragm began at an applied pressure of approximately 4 pounds per square inch. As shown in figures 7(a) and (e), deformation was unsymmetrical. A cornering effect started almost immediately, as seen in figure 7(b), but it did not seem to hinder deformation. Deformation took the form of a triangular pyramid-type deflection shown in figures 7(c) and (d). As the diaphragm neared the cylindrical section at the flange area, a double-fold-type deformation developed, which was typical of all the diaphragms tested. This is seen in figure 8 at a percent expulsion of approximately 60 percent. At approximately 65 percent expulsion, recycling was attempted to test the cycle capability of the diaphragm. Immediately, a torsional-type deformation developed (fig. 7(f)), similar to the twisting of a roll of paper. If recycling

had continued, failure of the diaphragm would have occurred because of the severe twisting action, so the direction of expulsion was again reversed until approximately 85 percent of the original volume was displaced. The diaphragm developed a leak at approximately 70 percent expulsion, but since this was a shakedown run it was decided to continue the test beyond initial failure to study the deformation process. Upon removal, the diaphragm was found to have torn at one of the double folds. Figure 9 shows the first diaphragm after removal from the containment sphere; the tear at the double fold is circled.
